# Failure analysis of a vibrating shaft in a fretting wear simulator

Young-Ho Lee \*, Jae-Yong Kim, Hyung-Kyu Kim

Korea Atomic Energy Research Institute, 150 Dukjin-dong, Yuseong-gu, Daejeon 305-353, Republic of Korea

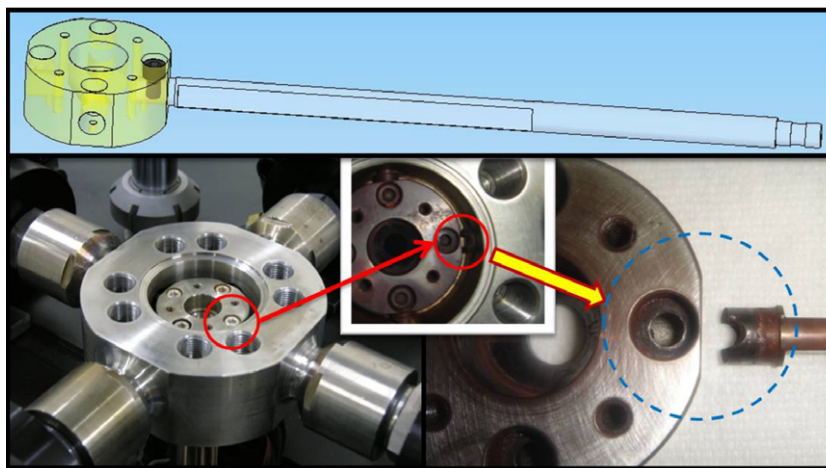
A vertical type of a fretting wear tester (FRETONUS, FRTting Tester Of Nuclear Systems) for a HTHP water condition was developed in order to evaluate the fretting wear behavior of nuclear components [2]. After 500 h tests, however, two vibrating shafts among four were fractured, which were connected to a specimen holder jig by using a bolt as shown in Fig. 2. It is

**Fig. 2.** Schematic views of the assembling method between the vibrating shaft and rod specimen holder jig and the fractured vibrating shaft after 500 h tests at high temperature and pressurized water condition.

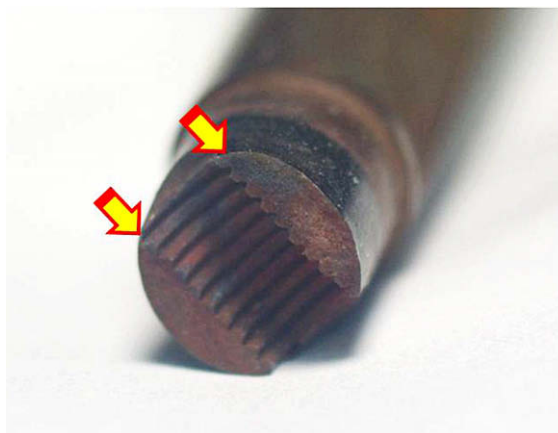
The vibrating shaft is made of a conventional high-carbon martensitic stainless steel (SUS 440C) and this material is widely used as tools or blades for use in relatively corrosive atmospheres [3]. The chemical composition and mechanical properties are listed in Table 1. Fig. 3 shows the OM result of the fracture surface for the vibrating shaft. Due to the HTHP water condition, the fracture surface was heavily oxidized and it was difficult to obtain metallographic proof by using the OM observation. However, it is expected that the failure was initiated at a contact region between the vibrating shaft and the fuel rod holder jig because these two parts were assembled by using a bolt as shown in Fig. 2. During the fretting wear tests, four vibrating shafts were reciprocated in their axial direction with a range of  $\pm 200\ \mu\text{m}$ , a frequency of 30 °Hz and a sinusoidal motion by two electro-magnetic actuators that were arrayed at an angle of 90°. To generate a circular motion of the fuel rod specimen which is regarded as a conservative simulation of an actual fuel rod vibration in operating NPPs, the phase difference of the sinusoidal waveform for the shake signals of two actuators is set to 90° as shown in Fig. 4. When the fuel rod specimen is vibrated with a circular motion, the contact region of the vibrating shafts with the fuel rod holder jig is expected to experience fatigue loads. Generally, striation traces that are distinct proof for a fatigue failure could be found easily on a fracture surface, if the structural materials are fractured under the fatigue loading conditions. However, the oxidized fracture surface of the vibrating shaft was examined by using SEM without any cleanings because the striation traces could be expected to remove by the oxide removal process (i.e. acid cleaning).

**Fig. 3.** OM result of the fracture surface for the vibrating shaft: arrows indicate the expected crack initiation region.

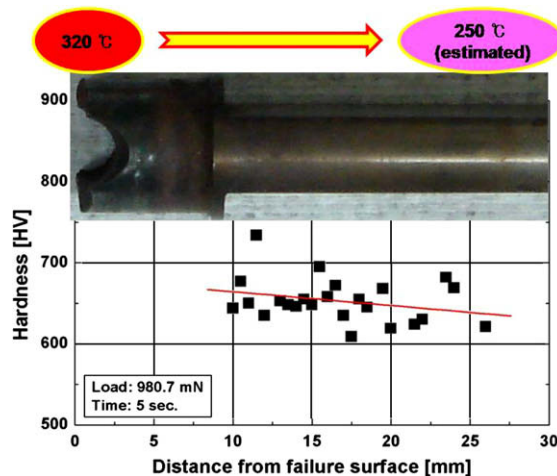
Before the SEM observation, it is necessary to examine the mechanical property changes of the vibrating shaft, because it was exposed to the HTHP water condition during 500 h tests. So, a micro-vickers hardness of the fractured vibrating shaft was measured and its result is shown in Fig. 5. It is apparent that the micro-vickers hardness value increased according to the exposed temperature for the vibrating shaft. This result corresponds well with the tempering temperature effect

Fig. 5. Measurement result of the micro-vickers hardness according to the exposed temperature for the vibrating shaft.

on the mechanical properties of SUS 440C [4]. In this study, the higher carbon martensitic stainless steel is likely to retain a large amount of untransformed austenite. It is thought that a delayed transformation may occur as temperature fluctuations in several fretting wear tests because the 500 h tests at about 320 °C did not have a negligible effect on the stress relieving of the vibrating shaft material. In addition, it is possible that some loss in ductility may result from a hydrogen embrittlement that is an important concern in martensitic stainless steels in a heat-treating atmosphere containing hydrogen in the form of distilled water.

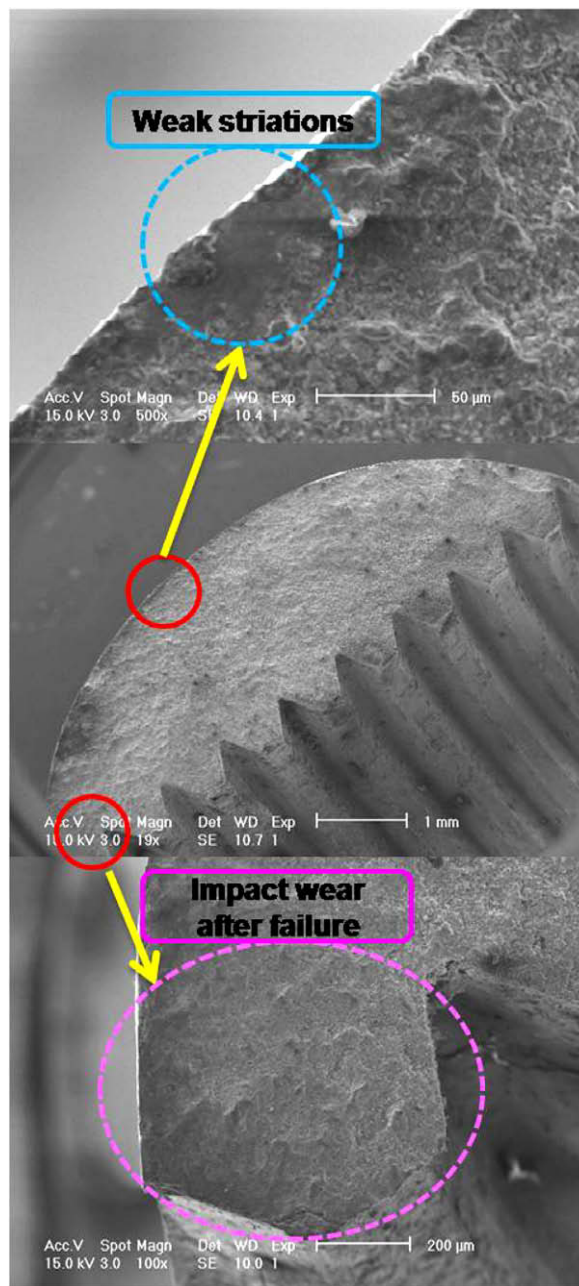
Fig. 6 shows the morphology of the fracture surface by using SEM. It is apparent that the fracture surface was almost covered with oxides and it is difficult to detect evidence of a fatigue failure such as striation traces. From a careful inspection of the results, however, weak striation traces appeared near a lateral outer surface. Also, a crack propagation trace was found at the contact region between the vibrating shaft and the fuel rod holder jig even though its characteristic could not be defined due to the severe oxidation in the HTHP water condition. One of the interesting results is that an impacting wear scar appeared in the fracture surface of the vibrating shaft. This result means that the impacting wear between the two fractured surfaces is generated after a fracture because the fractured vibrating shaft is continuously reciprocated by an electro-magnetic actuator regardless of the shaft failure. So, it is expected that the fatigue striation traces had disappeared and were covered by the impacting wear motion and by the wear debris with a severe oxidation, respectively. Consequently, the vibrating shaft failure is expected to be initiated by a contact fatigue at the contact region and then the contact force exerted by a bolt

**Fig. 6.** SEM micrograph of the fractured vibrating shaft surface.

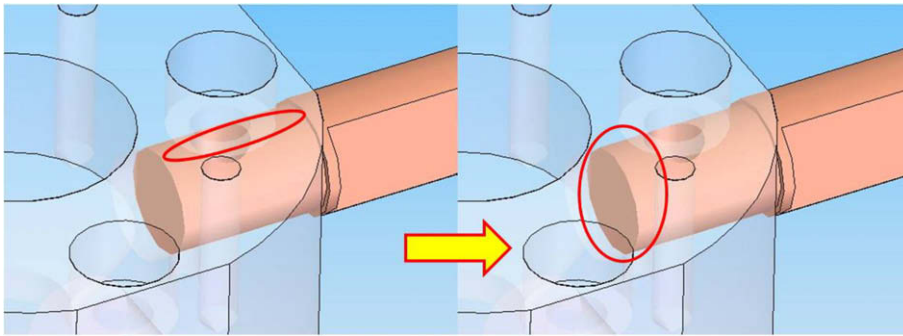
screw will be decreased gradually. At this time, the initial crack propagation is gradually retarded and the contact condition between the vibrating shaft and the fuel rod holder jig will be changed as shown in Fig. 7. So, it is necessary to examine the new crack initiation region by using a stress analysis, which could verify the maximum stress region of the vibrating shaft during a circular motion.

Fig. 7. Variation of contact condition between the vibrating shaft and the fuel rod holder jig after the retardation of initial crack propagation.

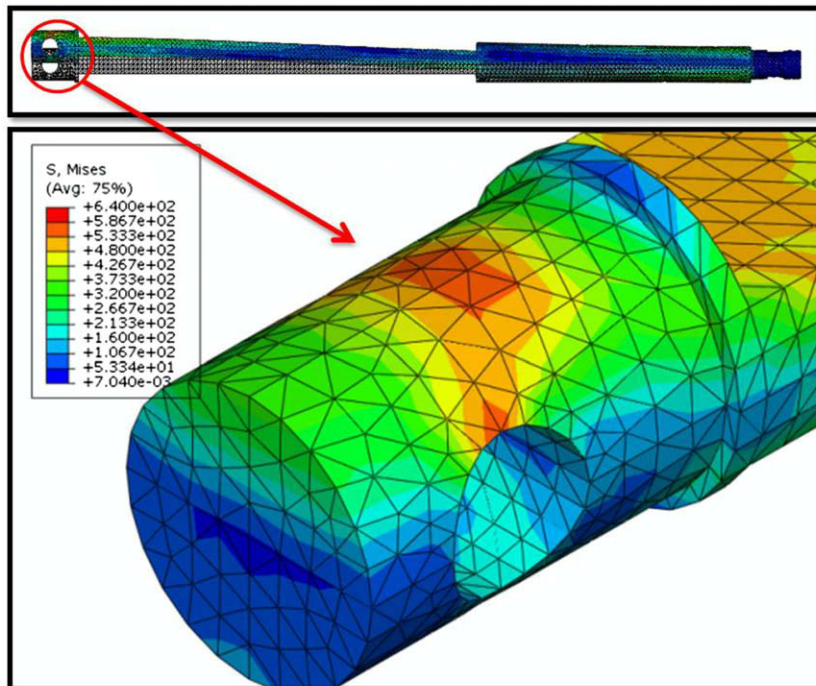
Fig. 9. Model of Von-Mises stress distribution in the vibrating shaft.

tribution in the vibrating shaft showed that the high stress concentrations were present at the edge of the thread hole and the lateral outer surfaces as shown in Fig. 9. In particular, the lateral face experienced stresses in the magnitude of approximately 640 MPa. This value is about half of the yield stress of the vibrating shaft. It is considered that these high stress concentrations are affected by the conservative boundary condition of the FE analysis. Consequently, the positions of the stress concentration are in good accord with the crack generation traces revealed in the SEM observation. Based on this result, the design of the vibrating shaft was modified to reduce the stress concentration between the contact surfaces and the thread hole size of it was decreased to increase the fatigue life cycle.

The reason for the failure of the vibrating shaft in the fretting wear simulator was investigated by using a measurement of the micro-vickers hardness, OM & SEM observations and a finite element analysis. Due to the heavily oxidized fracture surface and the impacting wear between the two fracture surfaces after a failure, it is difficult to obtain the metallographic proof by using the OM observation. However, the failure was expected to initiate at the contact region between the vibrating shaft and the fuel rod holder jig under the fatigue loading conditions. The vibrating shaft failure is expected to be initiated by the contact fatigue at the contact region and then the contact force exerted by a bolt screw will be decreased gradually. After the initial crack propagation is gradually retarded, the change of the contact condition results in a new crack initiation at a lateral outer surface. From the FEA results, the positions of the stress concentrations are in good accord with the crack generation traces revealed in the SEM observation. Based on this result, the design of the vibrating shaft was modified to reduce the stress concentration between the contact surfaces and the thread hole size of it was decreased to increase the fatigue life cycle.
