Development of AISI A2 Tool Steel Beater Head for an Impact Crusher in a Sinter Plant

Abstract Failure analysis of a tool steel (AISI A2) beater head of an impact crusher and development of suitable heat treatment process to improve its performance have been presented. The beater heads were failing prematurely by brittle fracture from its pin-hole locations. The investigation consisted of visual inspection, fractography, chemical analysis, characterization of microstructures using optical and scanning electron microscopes (SEM), EDS analysis, and determination of micro-hardness profile. Microstructural characterization using SEM and EDS analysis revealed significant amount of coarse continuous Cr-carbide networks in the martensite matrix. It increased hardness (64 HRC) as well as heterogeneity of the matrix as depicted by the micro-hardness profile, and decreased the toughness (3 J) since coarse carbide networks are very hard and brittle. The austenitizing temperature as well as tempering temperature of heat treatment was found lower at the manufacturer's end. The new recommended heat treatment resulted in lower amount of discontinuous Cr-carbides along with significant amount of

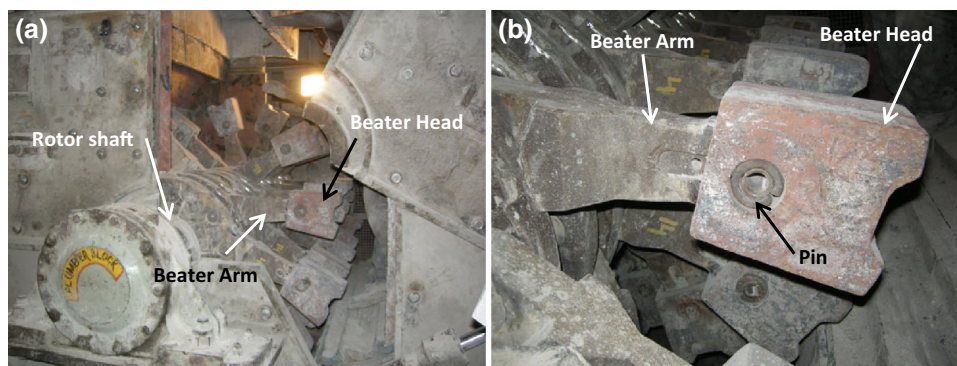
Fig. 1 (a) Impact crusher showing rotor shaft-beater head assembly, (b) closer view of a beater head

Figure 1(a) shows a rotor shaft-beater head assembly. Beater heads are attached to the beater arms with the help

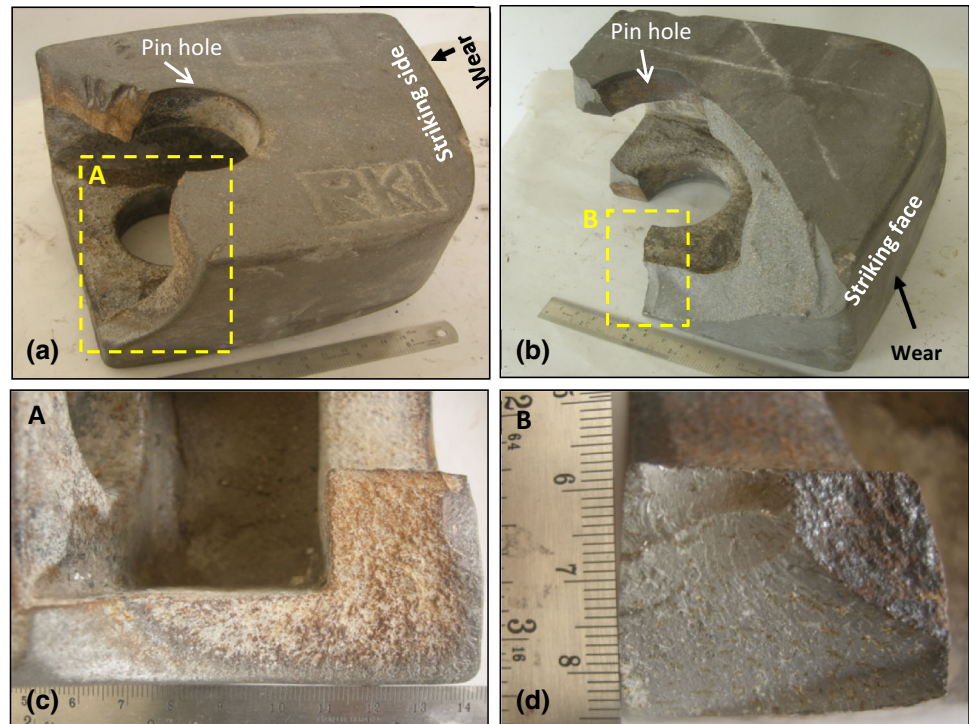
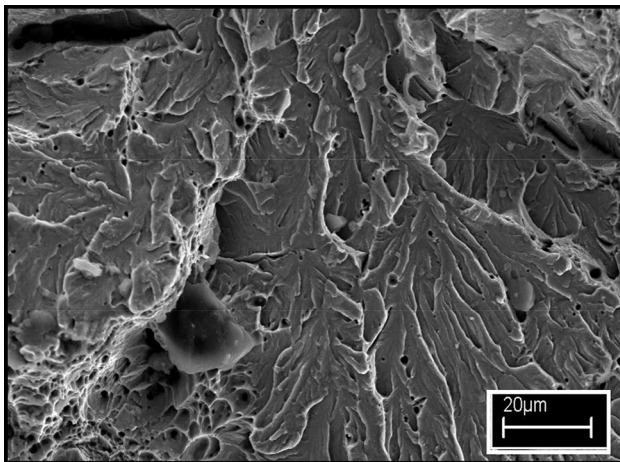
of pins inserted through the holes present in the beater heads as shown in Fig. 1(b). Figure 2(a) and (b) shows failed beater heads which fractured from their pin-hole locations. The fracture surfaces (Fig. 2c and d) of the failed beater head reveal bright granular appearance suggesting brittle fracture. The other end of the beater head was found to be worn out (Fig. 2a and b) due to abrasion or impact with input flux materials while crushing. While gradual wear of the beater head surface is a desired mode of failure, fracture from the pin-hole locations during service is a concern which must be addressed.

Fig. 2 (a, b) Beater head samples failed from the pin-hole locations, (c, d) closer view of fracture surfaces near the pin-hole of the beater heads

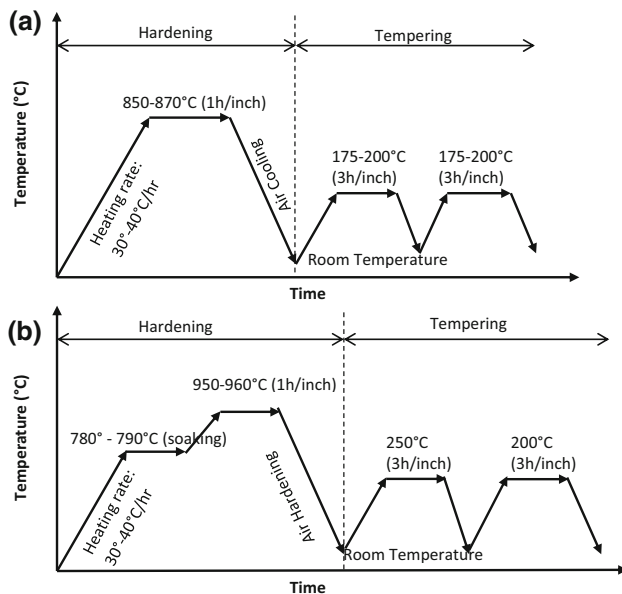
**Fig. 4** (a) Typical heat treatment schedule given by the manufacturer of beater head, and (b) recommended heat treatment cycle of beater head

making them discontinuous or isolated at certain locations apart from reducing their amount [5]. The heat treatment schedule (Fig. 4) given by the manufacturer showed a lower austenitizing temperature during hardening as well as temperature during tempering [2, 18]. Because of lower austenitizing temperature during heat treatment, the massive primary carbides which generated fine secondary carbides afterwards were not fully dissolved in the matrix; this yielded coarse carbide network with a little amount of fine secondary carbide precipitates imparting brittleness or poor toughness to the material [2, 5, 19].

- (3) Analysis of the heat treatment schedule given to the beater head exhibited that its improper microstructure was a result of lower austenitizing (850–870 °C) as well as tempering (175–200 °C) temperature during heat treatment at manufacturer’s end.

A proper heat treatment schedule as described in “Heat treatment of Beater Head in Laboratory for improvement” section was recommended to the manufacturer to improve the microstructure of beater head; austenitizing temperature was increased to 954 °C after preheating at 788 °C and tempering temperature was increased to 200–250 °C. The new heat treatment ensured significant dissolution of coarse primary carbide network in the matrix followed by precipitation of fine globular secondary carbide particles uniformly distributed throughout the matrix (Figs. 8 and 9). The recommended heat treatment schedule resulted in improved microstructure having an optimum combination of both hardness and toughness. The impact toughness of the material was found to increase from 3 to 6.5 J, i.e., by 117% with a hardness value desired as per the specification of the grade AISI A2. The hardness profile (Fig. 7b) also exhibited a relatively smooth trend compared to the earlier one ensuring a more uniform matrix. The new beater heads manufactured following the recommended heat treatment schedule, in fact, exhibited better performance compared to the earlier ones; the service life improved from 15 days to 2 months, i.e., by 4 times. The mode of failure of the new beater heads also changed from sudden brittle fracture to gradual wear at the striking face, the desired one.

- (4) The new recommended heat treatment schedule (preheating at 788 °C, austenitizing at 954 °C followed by two stage tempering at 200–500 °C) resulted in small amount of discontinuous carbide networks with significant amount of finely distributed precipitates of secondary carbides within tempered martensite matrix. The improved microstructure yielded an optimum combination of hardness (59 HRC) and toughness (6.5 J) which led to an increase in service life of the beater heads by four times.

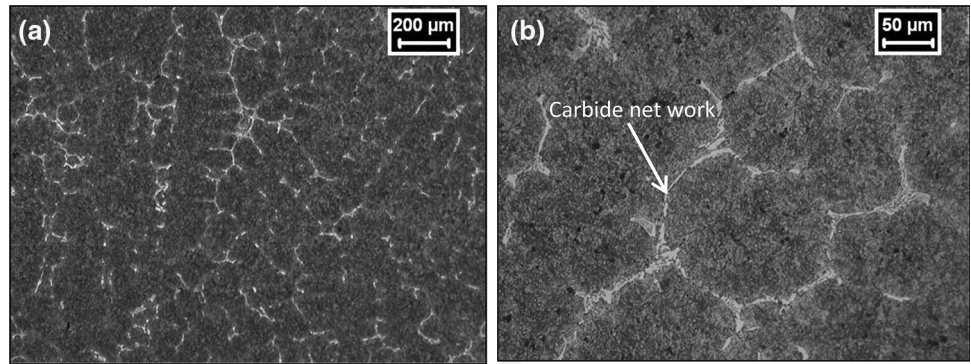
The most significant material properties required for the beater head component are hardness, toughness, and wear resistance. As the amount of carbides increases, the hardness and wear resistance also increase but care has to be taken in heat treatment to avoid loss of toughness [2, 3, 6, 7]. The clusters of coarse carbides detrimentally affect the toughness; the carbides being brittle are susceptible to initiate cracks during an impact in service [2, 8, 9].

Fig. 5 Microstructures of failed beater head: (a) Microstructure (at $\times 50$) shows martensite matrix along with carbide networks at the grain boundaries, and (b) microstructure at magnified view (at $\times 200$) shows continuous carbide network at the prior austenite grain boundary

- (2) Microstructural examination revealed significant amount of coarse grain boundary networks of primary Cr-carbides. Coarse Cr-carbide networks resulted in higher hardness (64 HRC) and lower toughness (3 J) of the tool steel material making it brittle.

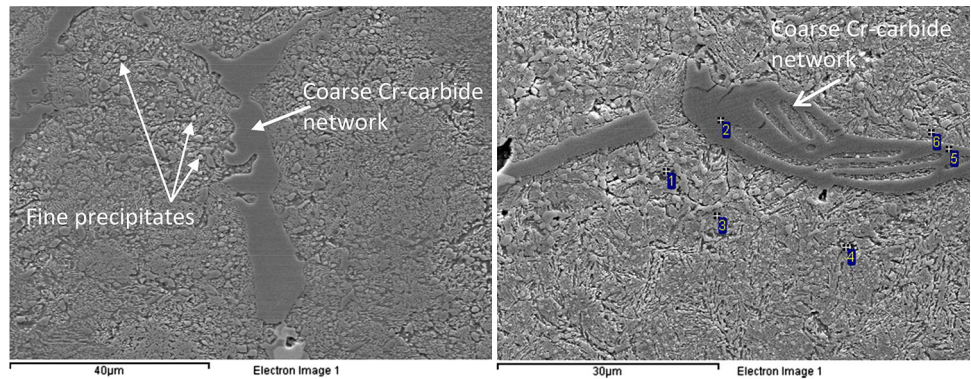
The etched cross-section of the sample was examined with the help of the scanning electron microscope (SEM) operated at an accelerating voltage of 15 kV for its microstructural as well as elemental characterizations. Micrograph showed coarse carbide network at the grain boundary along with some fine globular precipitates with the martensitic matrix (Fig. 6a and b). Energy dispersive spectroscopy (EDS) of the grain boundary network as well as fine precipitates (as marked in Fig. 6a and b) was carried out for their elemental characterization and the results of the analyses were compiled in Table 2. The results of EDS analysis indicate that the grain boundary network and the fine precipitates within the matrix are chromium carbides. The carbide stoichiometry could not be determined by EDS micro-analysis. But literature survey on similar materials [2, 10, 11] like AISI H11, H13, M2, D2 and so on, and electron probe micro analysis of similar carbides discussed in earlier literature [5, 12–15] suggests the grain boundary carbide network to be of M_7C_3 type (Primary Carbide) and the fine globular precipitates as $M_{23}C_6$ (where $M = Cr$) type (Secondary Carbide). The skeleton-like morphology of massive carbide network at the grain boundary as shown in Fig. 6(b) is apparently indicative of its eutectic

origin (primary carbide), i.e., origin at the solidification stage [2, 5, 8–10, 13]. On the other hand, fine globular precipitates within the matrix indicate secondary carbides which form during heat treatment of the casting [2, 5, 8, 11].

Fig. 6 SEM micrographs at the cross-section of beater head sample: (a) micrograph (at $\times 1000$) shows coarse carbide network at the grain boundary along with fine precipitates within martensite matrix, and (b) micrograph (at $\times 1500$) shows locations of EDS analysis on the coarse carbide network as well as fine precipitates within the matrix

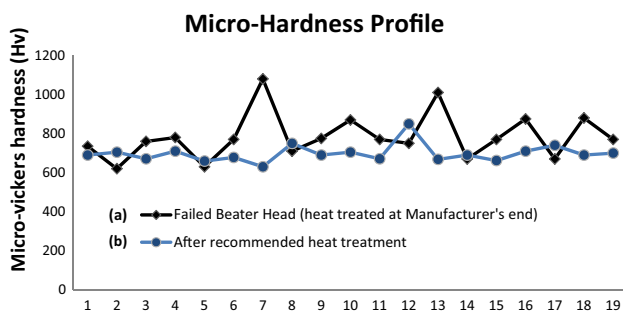
Both macro- and micro-hardness values were measured at the cross-section of the sample prepared from the failed beater head following the standard ASTM E384. Macro-hardness values were measured in a Vickers hardness testing machine with a load of 30 kgf. Five measurements were taken at random locations of the cross-section to get the average macro-hardness value; the macro-hardness value was found to be 781 ± 12 HV30 (equivalent to ≈ 64 HRC). The macro-hardness of the AISI A2 tool steel material was higher for its beater head application as higher hardness of the material adversely affect its toughness. Micro-hardness values were measured at a regular interval of 500 μm by a micro-Vickers hardness testing machine with a load of 50 gf and an indentation duration of 15 s; the micro-hardness profile is shown in Fig. 7(a). The hardness values are found to be varied in the range of 600–1000 HV0.05. Apart from hardness profile, micro-hardness values on some grain boundary carbide network were also measured separately. The average micro-hardness of carbide network was measured to 1375 ± 15 HV0.05; the measured micro-hardness value of carbide network is found to be similar to the value (1400 HV) for M_7C_3 type of primary Cr-carbide reported in other existing literature [12, 16].

Fig. 7 Micro-hardness profiles measured at the cross-section of the beater heads: (a) Failed beater head, and (b) after recommended heat treatment

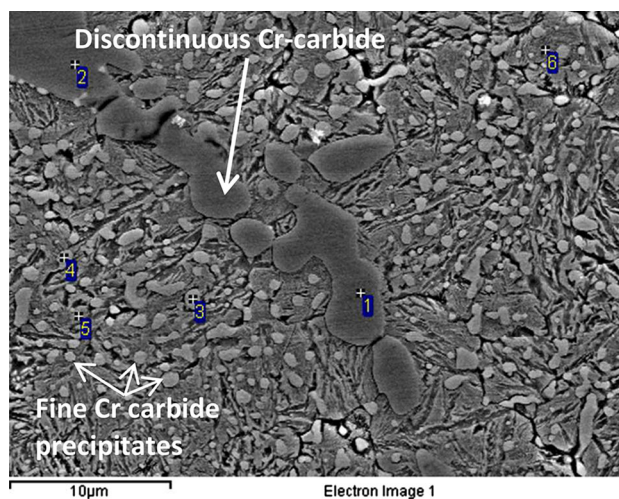
martensitic matrix with a small amount of primary eutectic carbides at the grain boundary. But these carbides are not in the form of continuous network rather they are discontinuous and present at some discrete locations on the grain boundaries unlike that observed in Fig. 5(a) and (b). Scanning electron microscopy (SEM) as well as EDS analysis of the carbides was carried out to study their morphology and type. SEM and EDS analyses show discontinuous primary Cr-carbides (M_7C_3 type) at the grain boundary and numerous globular fine carbide particles (secondary carbides- $M_{23}C_6$ type) uniformly distributed throughout the matrix as illustrated in Fig. 9 and Table 3.

Fig. 9 Discontinuous carbide network (at $\times 2500$) at prior austenite grain boundary along with fine globular Cr-carbide precipitates within the matrix

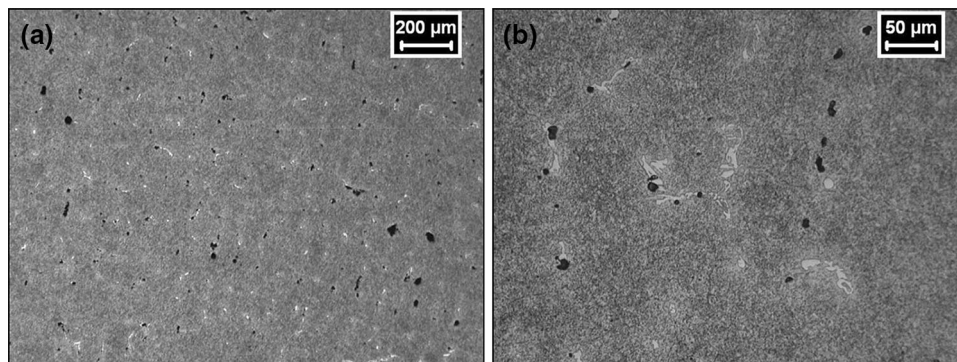
A sample was prepared from the beater head block heat treated in the Laboratory for examination of the microstructure following the procedure as described in “Microstructural Examination” section. The optical microstructures are shown in Fig. 8(a) and (b). The microstructures reveal predominantly

Fig. 8 (a) Microstructure (at $\times 50$) of beater head after suggested heat treatment, (b) Microstructure (at $\times 200$) shows martensite matrix with discontinuous carbides at discrete locations on the prior austenite grain boundary
