# Failure analysis of a vibrating shaft in a fretting wear simulator

Young-Ho Lee \*, Jae-Yong Kim, Hyung-Kyu Kim

Korea Atomic Energy Research Institute, 150 Dukjin-dong, Yuseong-gu, Daejeon 305-353, Republic of Korea

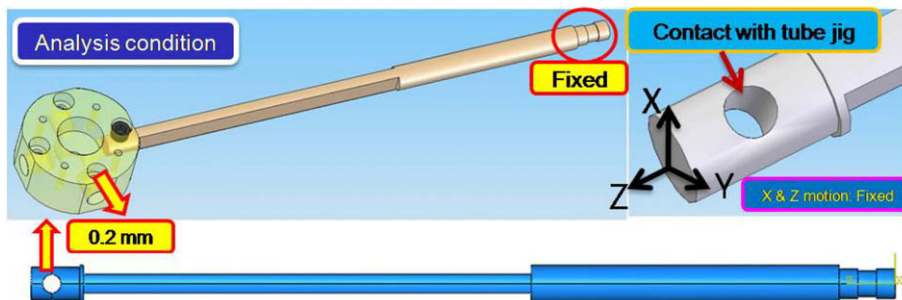
Fig. 8. FE model of the vibrating shaft generated by using a commercial 3D modeler.

In order to analyze the stress distribution that the vibrating shaft experienced during the initiation of the new crack, the FE model with 10 mm in diameter and 233.5 mm in length was created by using the commercial 3D modeler, SolidEdge V.19 as shown in Fig. 8. The displacement of the constrained cylinder at the left side is 0.2 mm and the connected region with the electro-magnetic actuator at the right side is fixed. The 4 node linear tetrahedron elements were used for the vibrating shaft.

The FE model consisted of about 10,100 nodes and 47,200 elements. The used elastic modulus, yield strength, density and Poisson's ratio of the commercial SUS 440C are listed in Table 1. The commercial code, ABAQUS Standard ver. 6.6–3 [5], was used to post-process the model in order to calculate the Von-Mises stress of the vibrating shaft. The Von-Mises stress dis-
